Property Inspection Report

LOCATED AT:
210 Nice Street
San Antonio, Texas 78109

INSPECTED ON:
Wednesday, April 14, 2021

Inspector, Kyle D. Scott TREC 23813
Ensure Home Inspections

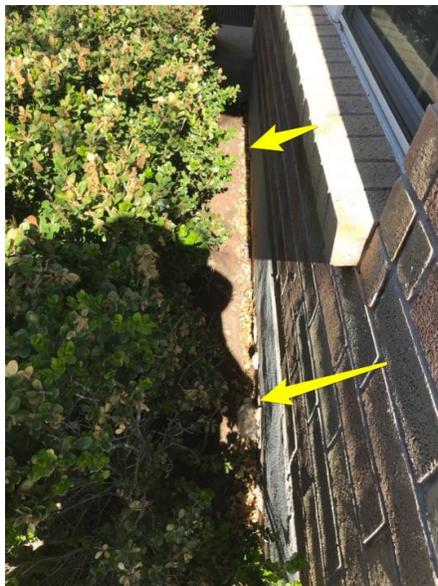
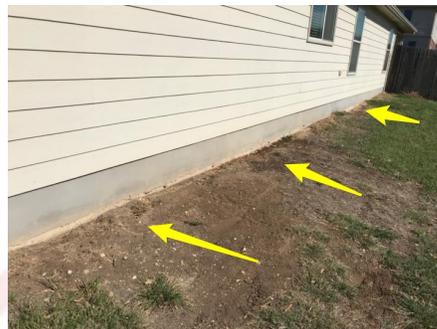
Inspector observed the soil line around the foundation to be too low in some areas or indicators of soil erosion near the foundation. Adequate soil underneath and around a foundation is necessary for proper distribution of the load placed upon the foundation by the weight of the home, and eroded soil should be replaced to prevent ponding of water near the foundation.

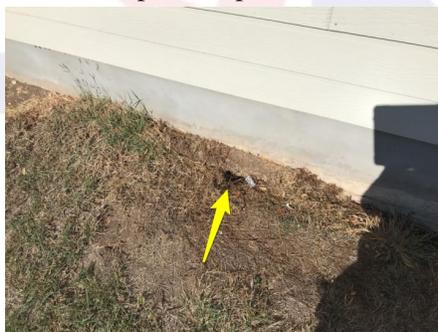
Some of the soil around the foundation appeared to have been excavated or eroded away. Some of the soil did not appear to be in contact with and supporting the foundation in these areas. Adequate soil underneath and around a foundation is necessary for proper distribution of the load placed upon the foundation by the weight of the home.

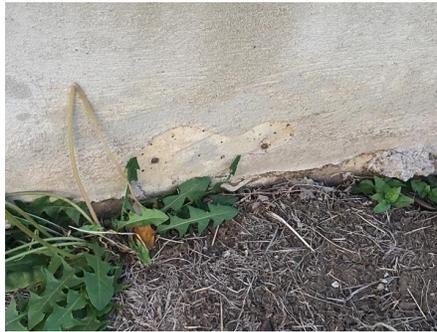
Inspector observed sections of exposed and rusted reinforcement bar (rebar) or steel at one or more areas of the foundation. TREC Standards of Practice require this be reported as "deficient".

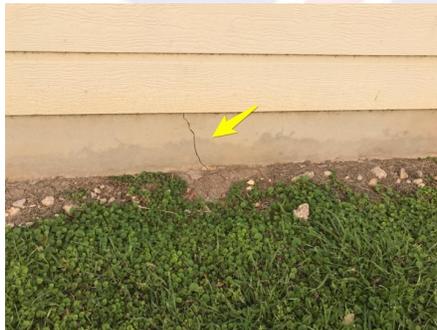
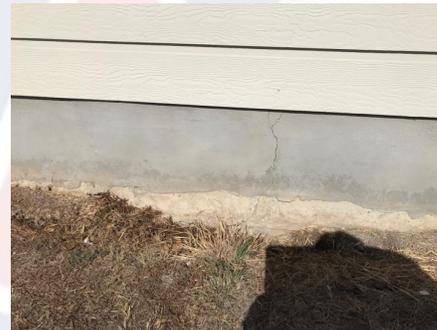
Inspector observed cracking in the foundation perimeter beam (the vertical sections of the foundation visible from the exterior) at one or more areas, including some cracking that appeared to extend across the foundation. This is a potential indicator of adverse foundation performance.

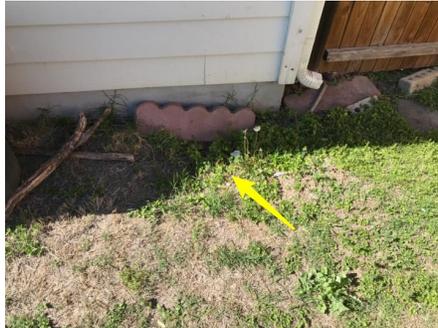
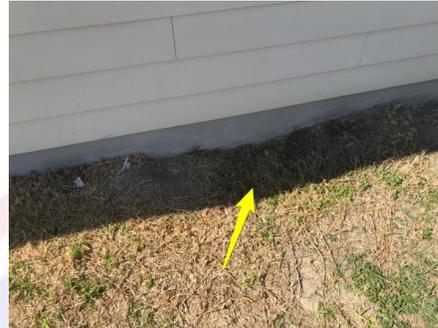
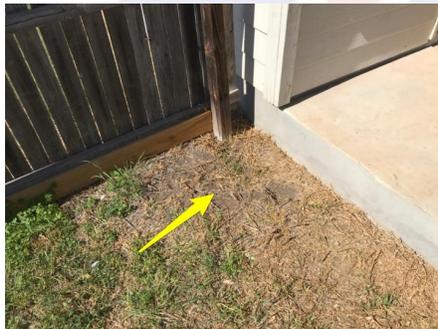
Inspector observed low spots in the finished grade (ground) at one or more areas around the foundation. The low spots in the finished grade adjacent to the foundation perimeter wall should be filled in to help prevent water from standing and/or ponding next to the foundation area.

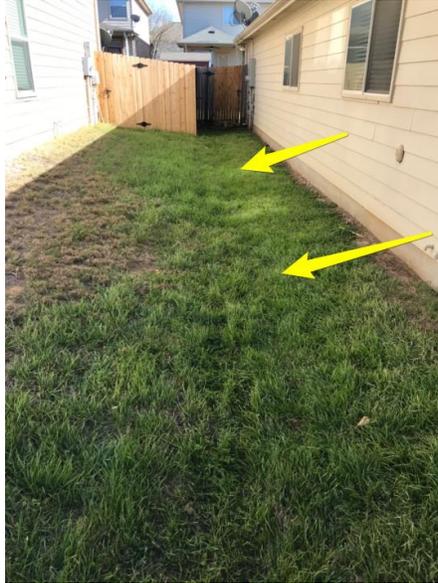
Inspector observed marginal site drainage at some areas around the exterior of the structure. Proper drainage is needed to help prevent water from standing and/or ponding next to the foundation beam. Inspector recommends continued monitoring of the areas around the foundation and further evaluation and corrective measures from qualified professional if water stands within 10-feet of the foundation perimeter beam for more than 24-hours.

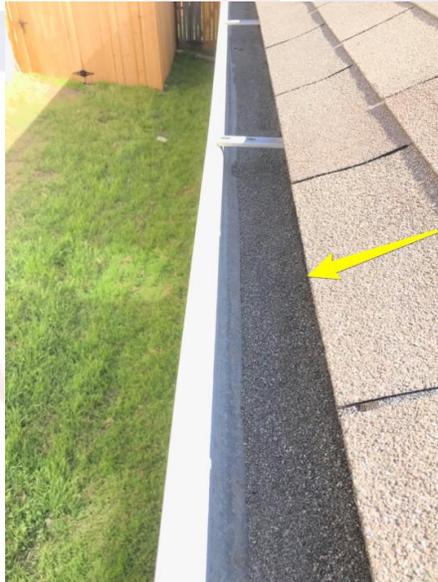
Inspector observed gutters that were filled with debris in one or more areas, blocking drainage. Inspector recommends cleaning of gutters by qualified professional.

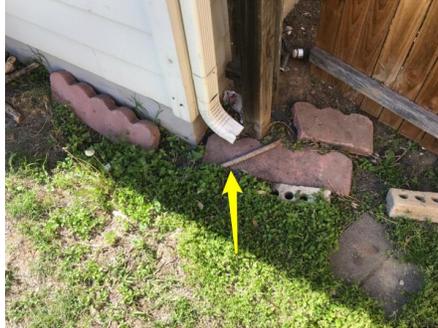
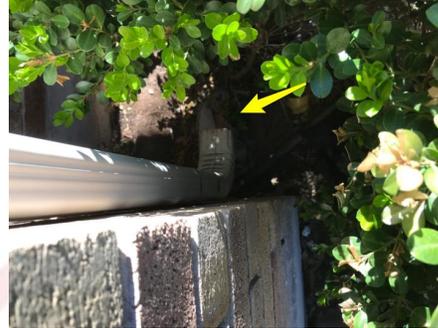
Inspector observed one or more gutter downspouts that terminate too close to the foundation. All gutter downspouts should discharge at least 3-feet away from the foundation. Inspector recommends installing downspout splash-blocks or extending downspout to discharge farther from foundation.

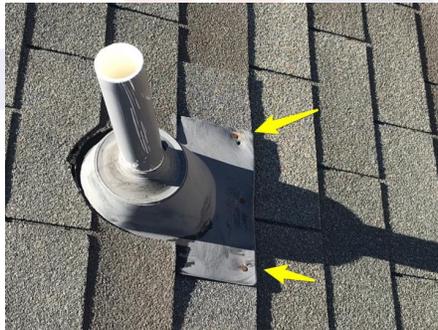
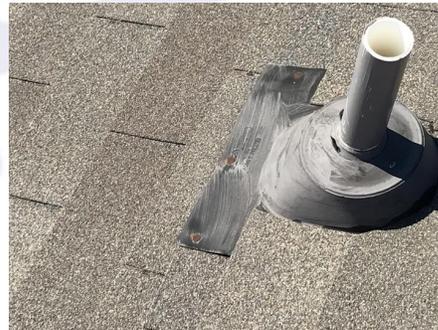
Inspector observed exposed or otherwise uncaulked nails on the roof surface, such as nails used to adhere shingles or flashings to the roof surface. Inspector recommends caulking of all exposed nails and nail-heads by qualified professional to help prevent future leak point in roof surface.

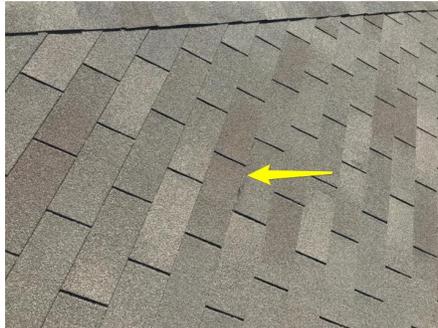
Some of the asphalt composition shingles on the roof surface appeared to be damaged or deteriorated.

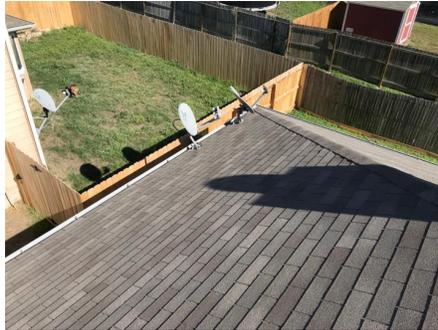
Inspector observed the presence of one or more satellite dishes on the roof surface. Testing the operation and/or reception of the antennas is beyond the scope of this inspection. This is not a deficiency, but inspector recommends continued monitoring of area around and below satellite for evidence of water penetration.

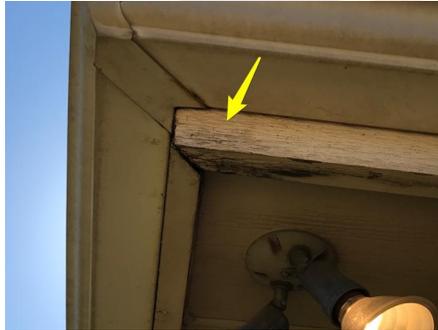
Inspector observed deteriorated fascia board at one or more areas of the exterior roof structure.

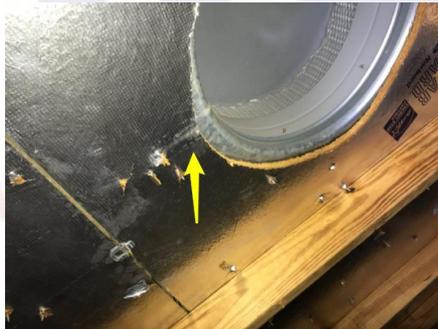
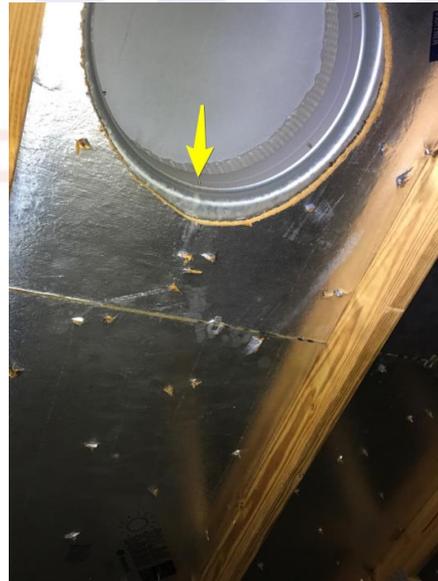
At least two of the four roof vents appeared to have leaked at some point. Mineral residue was observed on some portions of the observable roof vents and damaged drywall or other indicators of water leaks were observed below the vents. Two of vents were inaccessible. Inspector recommends further evaluation of the roof vents and correction as necessary by a qualified roofing professional.

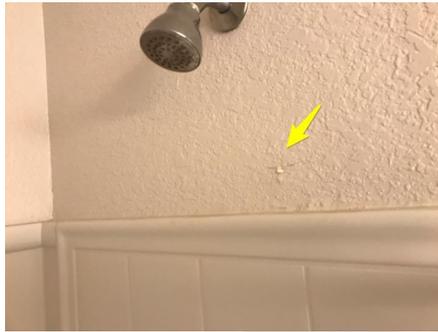
Inspector observed one or more sections of drywall where drywall joint tape, drywall paper, or paint appeared to be peeling, cracking, bubbling, or deforming in one or more locations of the interior walls. Inspector recommends continued monitoring of walls for signs of water penetration for further drywall tape peeling/cracking.

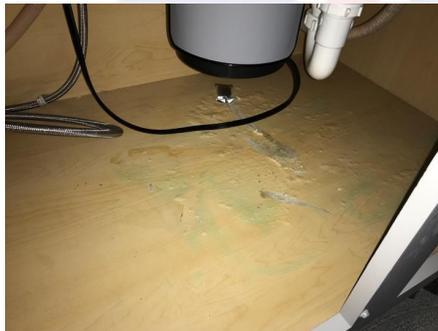
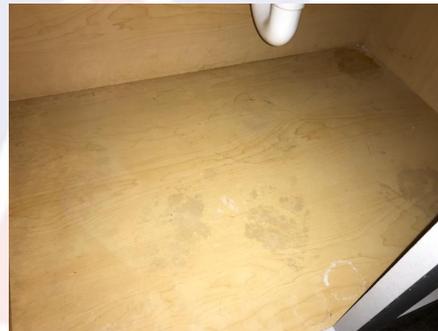
Inspector observed water damage or evidence of a prior leak inside of one or more sink cabinets, to include previous water damage that had been painted over, caulked over, boarded over or otherwise concealed.

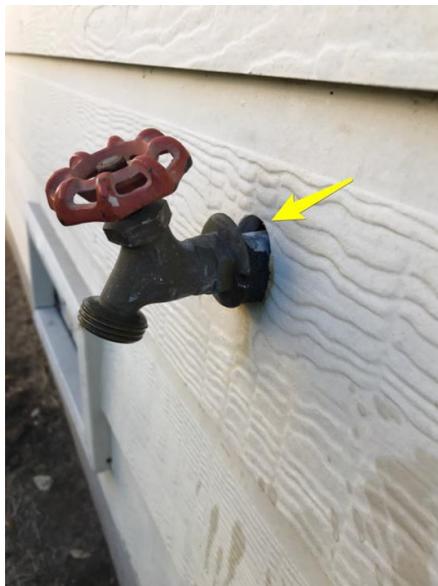
Inspector observed gaps, openings or voids in the exterior wall-cladding that could allow for the penetration of water or allow entry of pests into the home. Inspector recommends replacing any absent, damaged or deteriorated siding and sealing all gaps or voids in exterior walls exterior-rated sealant to prevent penetration of water or entry of pests.

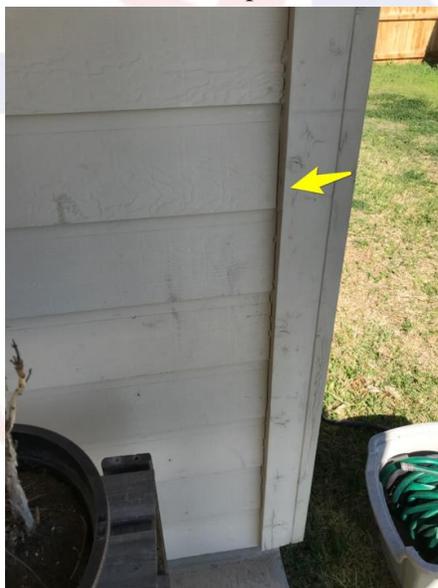
Inspector observed absent and/or deteriorated caulking or other exterior sealant (including mortar or grout) at one or more areas of the exterior wall-cladding where that could allow water to enter the structure. Inspector recommends sealing these gaps or openings with exterior-rated water-proof sealant.

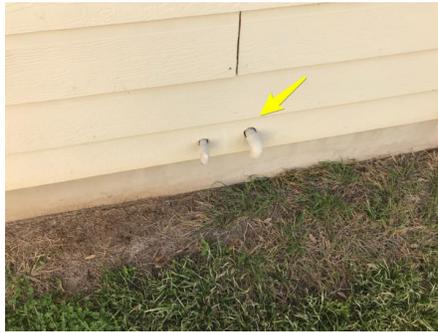
Inspector recommends sealing all exterior wall penetrations or openings, such as plumbing penetrations and escutcheons, electrical penetrations and nail/screw holes with exterior-rated sealant to reduce possibility of water penetration into structure interior. Inspector recommends using elastomeric sealant.

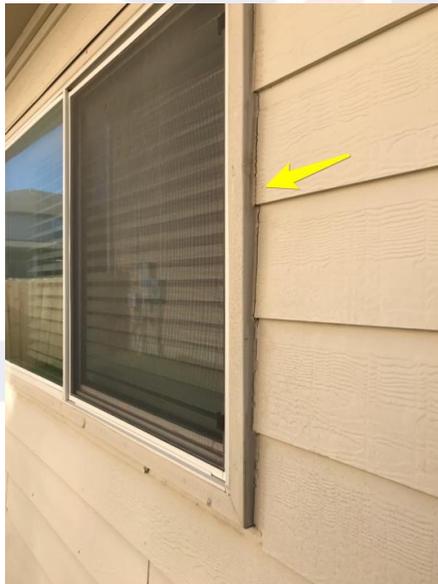
Inspector observed separations or gaps between the exterior wall-cladding and exterior window or the window's components (frame, casing, trim) at one or more areas of the exterior. Inspector recommends sealing these gaps or openings with exterior-rated water-proof sealant.

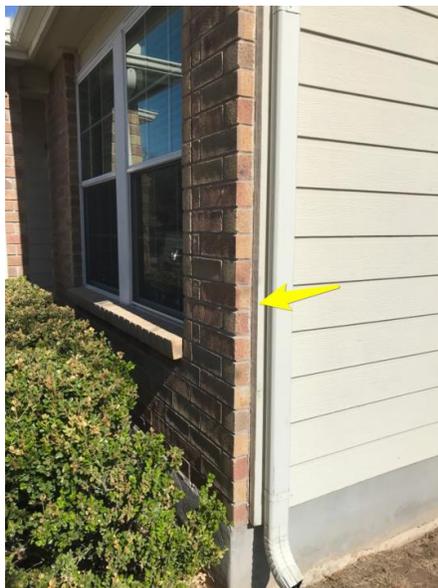
Inspector observed exterior siding, casing, or trim separations from the exterior wall-cladding at one or more areas.

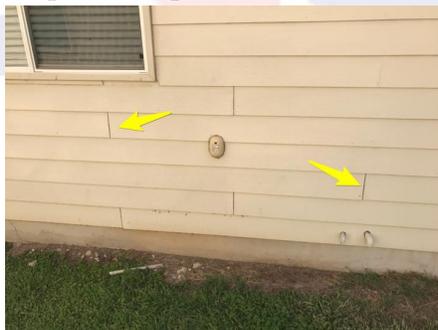
Inspector observed that the lapping cement-board siding "butt" joints or the vertical joints where cement-board siding pieces meet appear to have been previously caulked, and that the caulk sealing these joints is either absent on some joints or is deteriorated. While caulking is not the only means of preventing water penetration on these joints, inspector cannot verify at time of inspection if a flashing of any sort was installed behind these joints without removing the pieces. Inspector recommends sealing these joints with exterior-rated water-proof sealant.

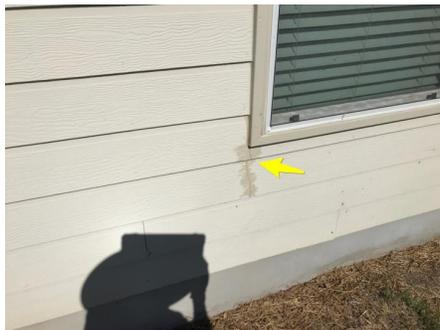
Inspector observed damaged and/or deteriorated cement-board siding at one or more areas of the exterior walls, to include cracking, chipping, physical damage, or any other breakage of the cement-board.

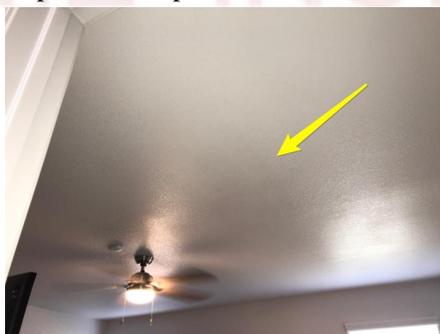
Master

Inspector observed indications of drywall repairs/patching or what looked like drywall repairs at one or more areas of the interior ceiling. This may include different types/styles/thicknesses of drywall texture observed in different areas of the home. Inspector recommends continued monitoring of these areas. While not deficient, drywall repairs on a ceiling may be indicators of prior water penetration.

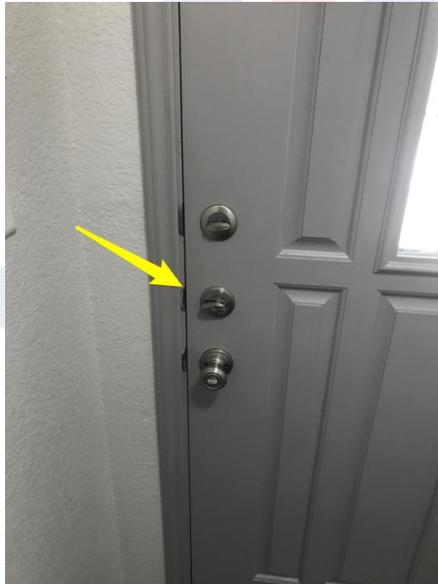
Inspector observed one or more doors that rubbed against or were impeded from closing by the door's strike plate. This condition may be a result of improper installation or this may be an indicator of adverse foundation performance.

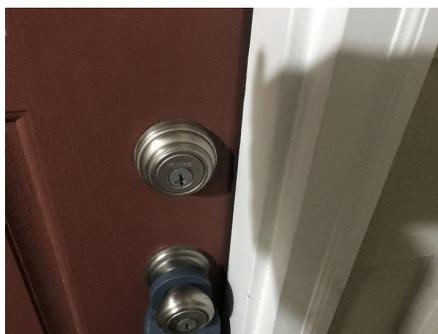
front door

One or more deadbolts was loose at time of inspection.

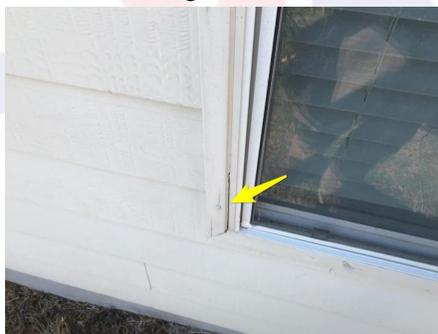
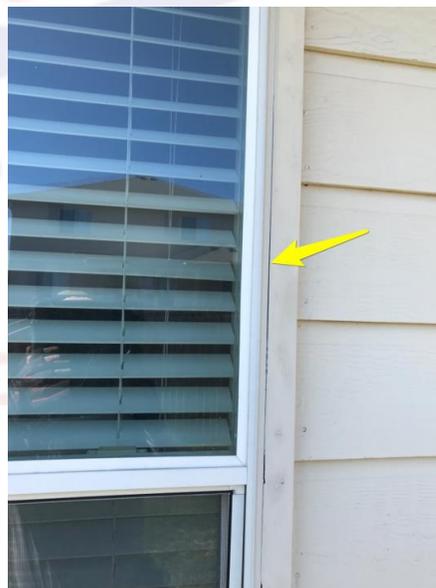
Inspector observed one or more exterior windows where caulking/sealant is absent or is deteriorated. Inspector recommends sealing any gaps or openings present around window exteriors or their casing (excluding weep holes) to reduce the possibility of water penetration into surrounding materials.

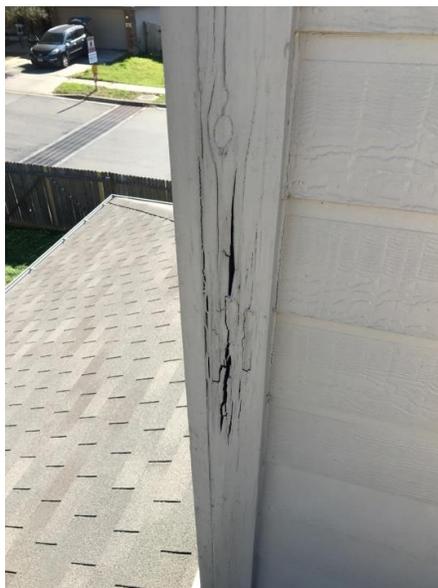
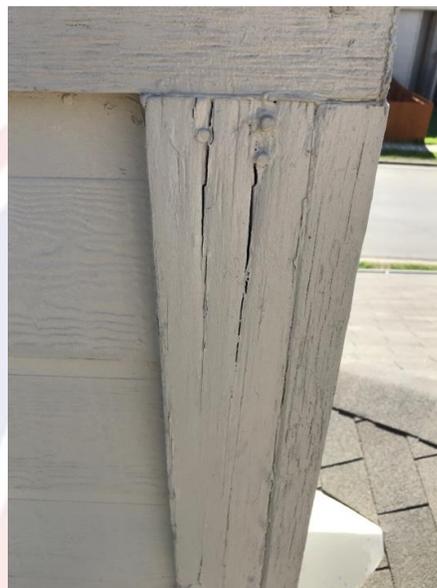
The wood casing or trim of the chimney structure was deteriorated in some areas. Some of this wood may be rotted and should be replaced as rotted wood is a conducive condition for wood-destroying insects. Exposed or unpainted wood surfaces should be caulked and painted to reduce deterioration from the exterior elements.

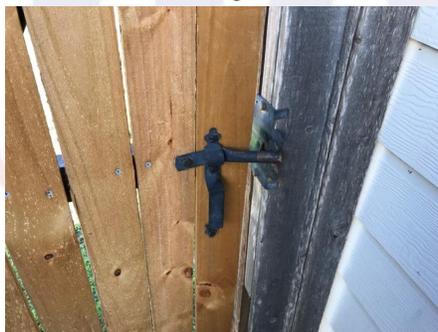
One or more fence gates does not latch closed.

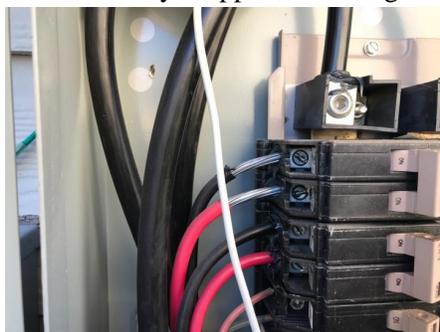
One or more of the wires inserted into circuit breaker(s) in the main breaker panel appeared to be excessively stripped, revealing more of the energized portions of the wire than necessary.

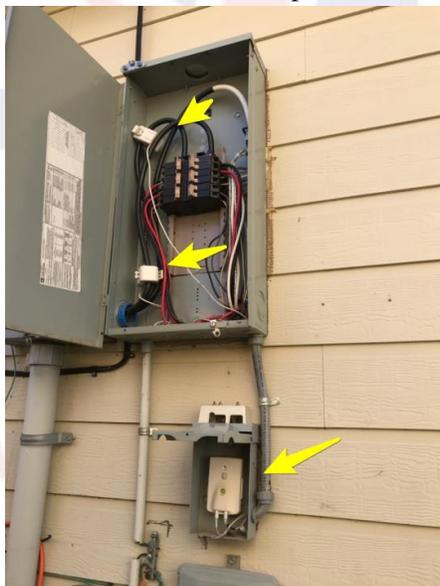
Inspector observed what appeared to be an electricity monitoring device installed near the main electrical panel. Inspector recommends consulting the home seller for more information about this device or its operation.

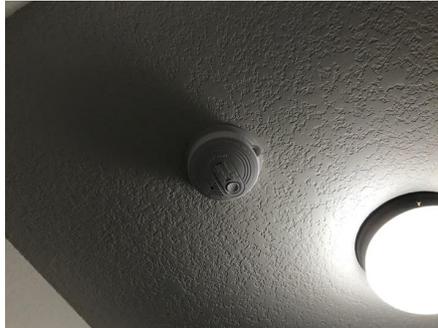
Inspector observed one or more smoke or carbon monoxide alarms that were disassembled (including having their batteries removed) or not functioning at time of inspection. Inspector notes that dead battery is a possibility. Inspector recommends replacement of all alarm batteries, and replacement of all non-functional alarms by licensed electrician. Inspector recommends consideration to replacing all smoke alarms and carbon monoxide alarms older than 10 years.

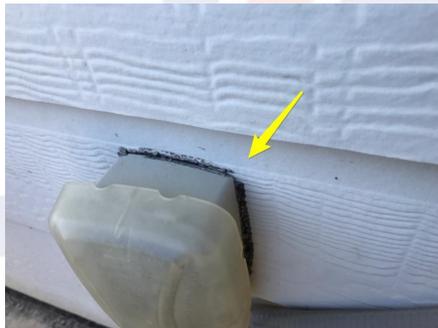
Inspector observed absent or deteriorated sealant where one or more exterior weather-resistant receptacle covers meet the exterior wall-cladding, and inspector recommends sealing these areas with exterior-rated waterproof sealant.

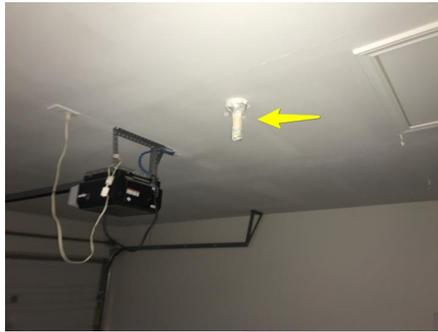
One or more of the light fixtures appear to be inoperative. This may be due to a broken or burned out bulb or some other unknown condition. This condition should be further evaluated and corrected as necessary.

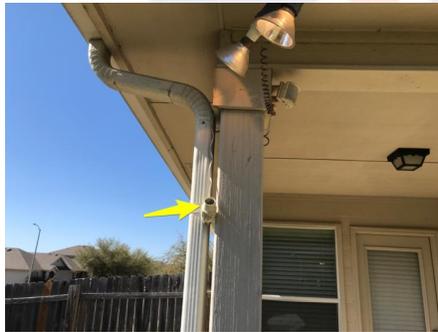
Energized light sockets were observed dangling from at least two exterior light fixtures. Inspector recommends disconnection of these extra light sockets by licensed electrician.

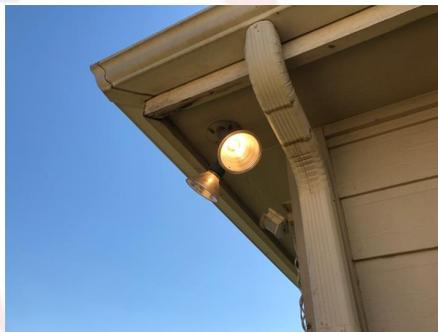
Inspector recommends replacing halogen lightbulbs with a more efficient lightbulb.

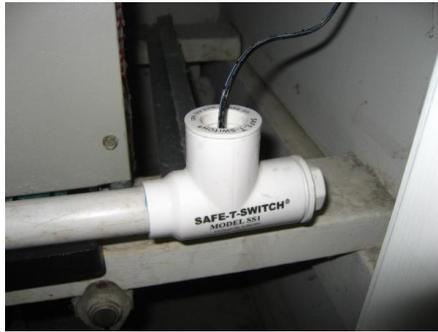
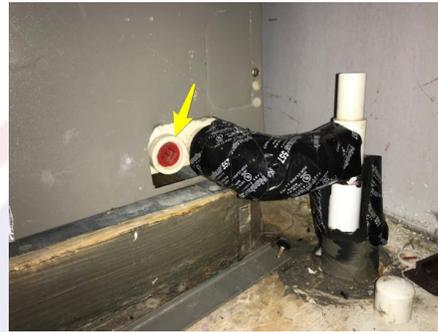
Inspector observed an evaporator coil that did not have required secondary condensate drain line installed or an electric shut-off switch as a prevention against flooding. A secondary condensate drain discharging to the exterior of the structure OR an electronic shutoff switch is **required** to be installed on all split-system cooling systems unless an auxiliary drip pan (that discharges to the exterior or has an electric shutoff device of its own) is present underneath the evaporator coil. Inspector strongly recommends installation of electronic safety shutoff switch by licensed HVAC professional to reduce possibility of clogged condensate drain causing water damage to surrounding area.

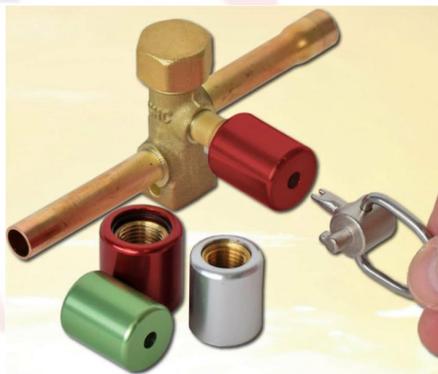
Inspector observed the absence of tamper-resistant refrigerant line caps on one or more exterior condenser units, a mechanical-code requirement.

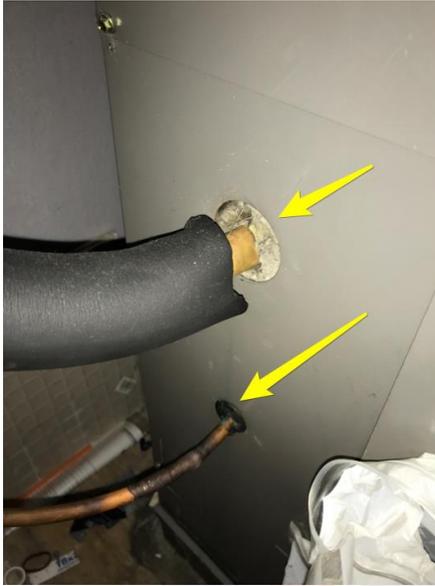
The larger suction side refrigerant pipe insulation is not sealed to the evaporator coil cabinet. This condition may allow condensation to form on the refrigerant line and drip onto the surrounding materials and is a potential air-leak. Inspector recommends qualified professional seal the insulation to the cabinet.

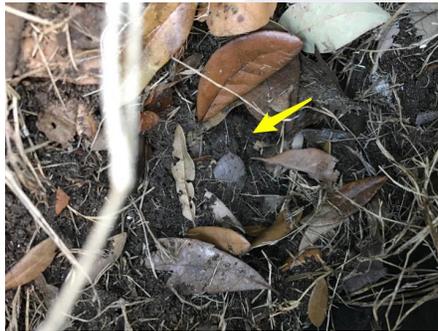
Inspector observed what appeared to be a pressure-regulator valve (PRV) installed in the ground near the water meter, but the valve was buried with dirt and inspector could not verify that this object was a PRV.

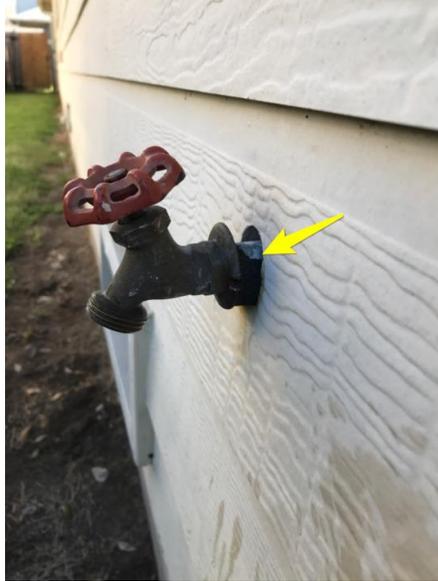
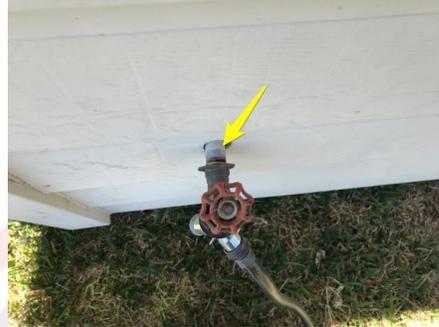
Inspector observed one or more sections of the water supply piping in unconditioned spaces (attic, garage, crawlspace, exterior) that did not have the required pipe insulation installed or where there were gaps in the pipe insulation. Pipe insulation is required on water supply piping in unconditioned areas for reasons of energy efficiency and to reduce the possibility of damage to the pipes during freezing temperatures.

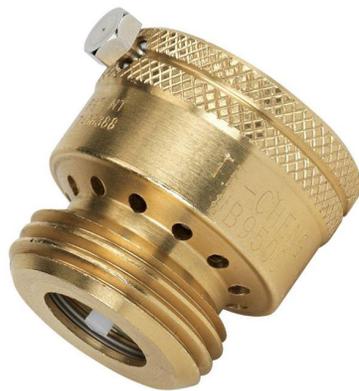
At time of inspection, inspector observed one or more exterior water spigots or hose bibbs without screw-on back-flow prevention/anti-siphon devices installed, and TREC Standards of Practice require we report this as deficient.

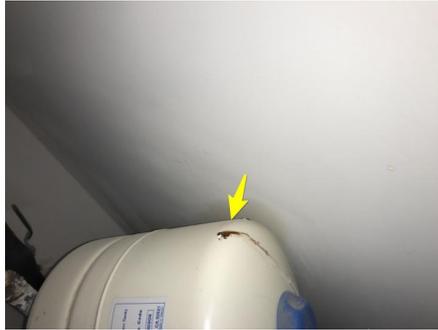
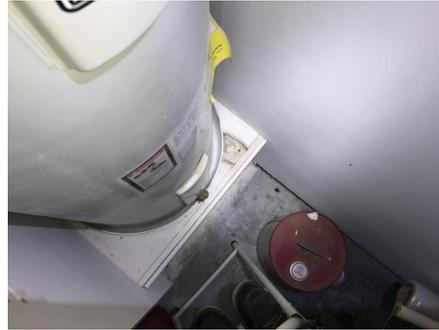
An active leak was observed on the expansion tank or near the expansion tank of one or more water heaters. Inspector recommends correction by licensed plumber.

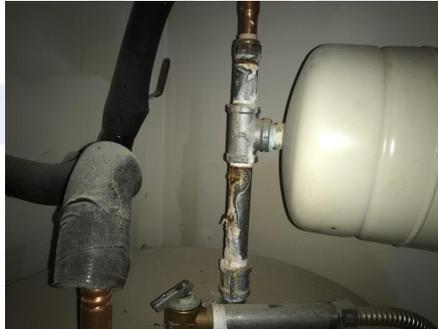
Rust, corrosion, mineral residue or deterioration of the water supply piping/connectors was observed at some of the water supply piping or water connectors for one or more water heaters. Inspector interprets these observations as indicators of prior leakage. Inspector recommends further evaluation and replacement of rusted or corroded piping, connectors or valves by licensed plumber.

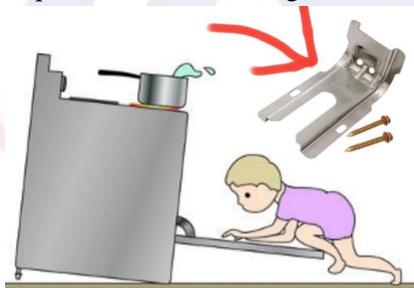
Inspector observed the absence of an anti-tip device installed on the oven, a manufacturer's requirement and building-code violation we are required to report as deficient.
