Property Inspection Report

LOCATED AT:
210 Nice Street
San Antonio, Texas 78109

INSPECTED ON:
Wednesday, April 14, 2021

Inspector, Kyle D. Scott TREC 23813
Ensure Home Inspections

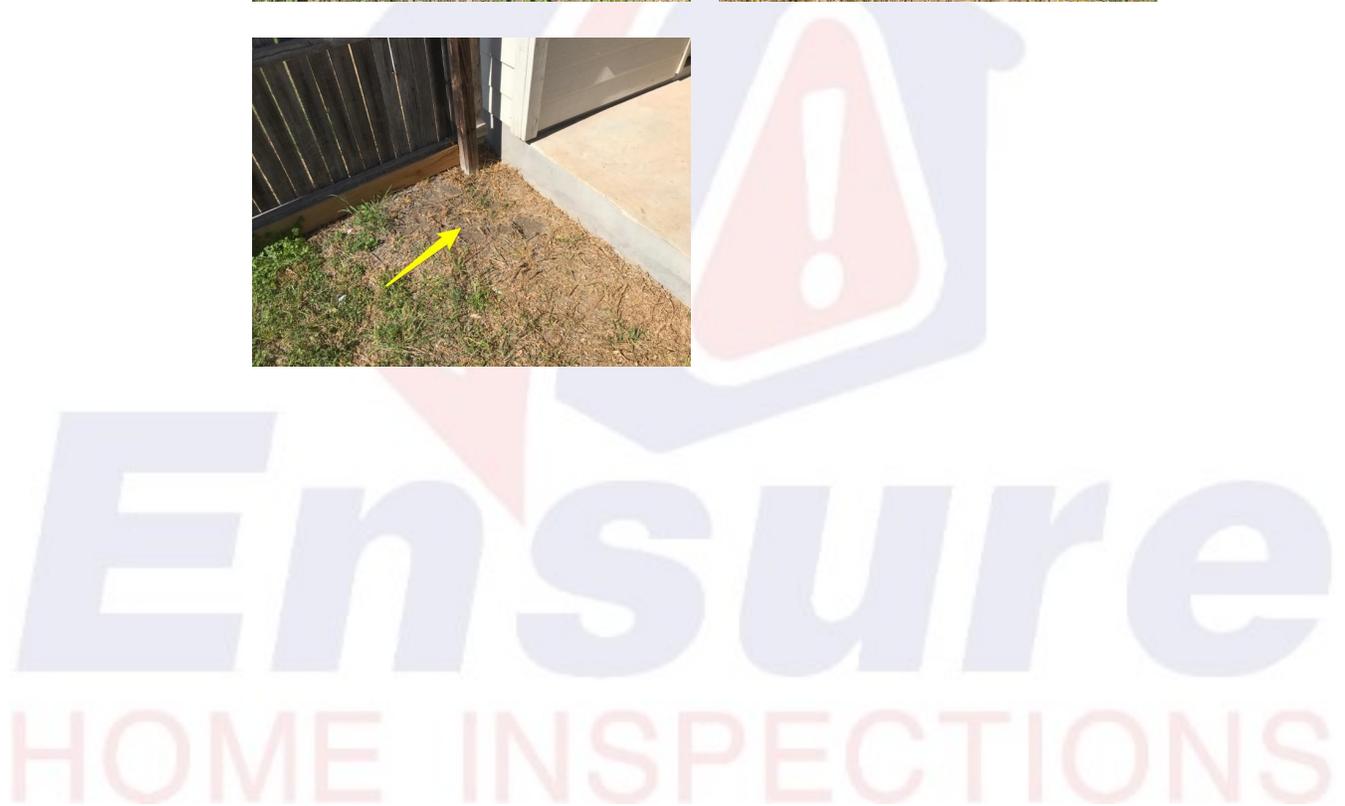
Grading

Inspector observed low spots in the finished grade (ground) at one or more areas around the foundation. The low spots in the finished grade adjacent to the foundation perimeter wall should be filled in to help prevent water from standing and/or ponding next to the foundation area.

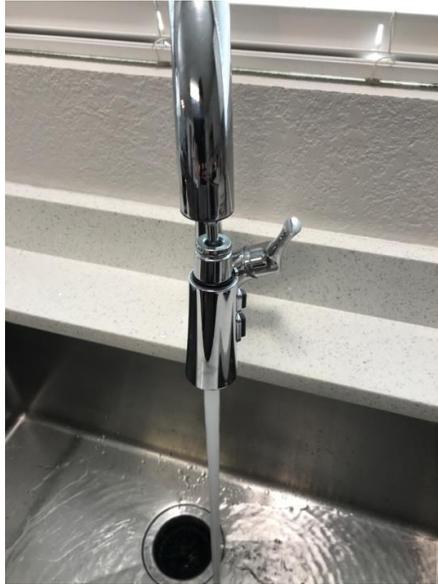
The weight attached to the kitchen faucet sprayer (in the cabinet below) may need to be adjusted for the sprayer to sit in the faucet.

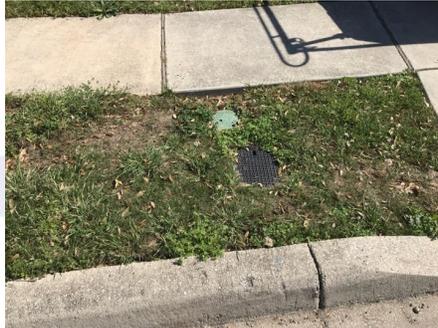
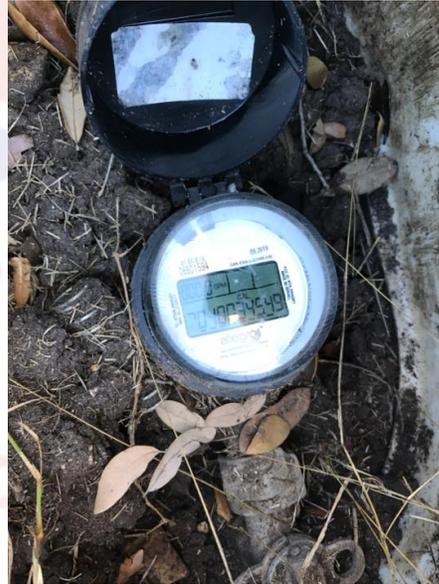
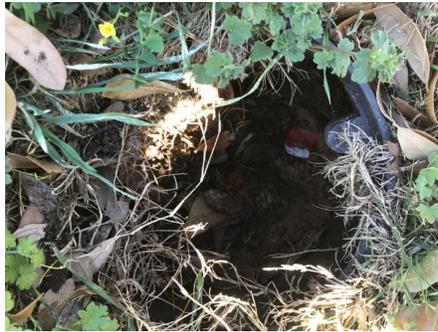
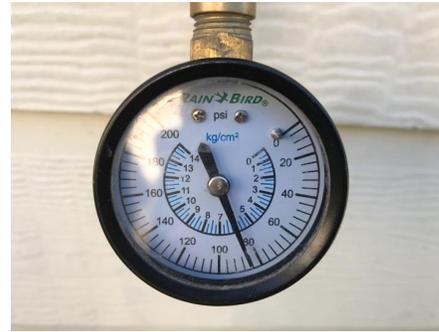
Photographs of the main water supply system:

Inspector observed what appeared to be a pressure-regulator valve (PRV) installed in the ground near the water meter, but the valve was buried with dirt and inspector could not verify that this object was a PRV.

The water meter enclosure, water shutoff valve enclosure and/or the pressure-regulator enclosures (if present) were filled with dirt, leaves or other debris at time of inspection. Inspector recommends removing excess dirt, leaves or debris for easy access to the items contained in the enclosures.

Inspector observed one or more sections of the water supply piping in unconditioned spaces (attic, garage, crawlspace, exterior) that did not have the required pipe insulation installed or where there were gaps in the pipe insulation. Pipe insulation is required on water supply piping in unconditioned areas for reasons of energy efficiency and to reduce the possibility of damage to the pipes during freezing temperatures.

After testing water pressure at hose bib, inspector determined that water pressure at this home is above the recommended range of 40-80 psi. Inspector did observe what appeared to be a pressure-regulator valve installed on the main water supply piping, but inspector cannot verify its operation and recommends further evaluation and correction as necessary by licensed plumber to bring the pressure down to a more acceptable range.

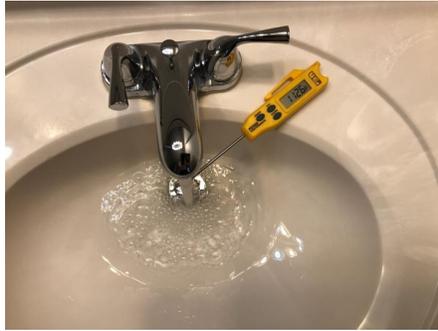
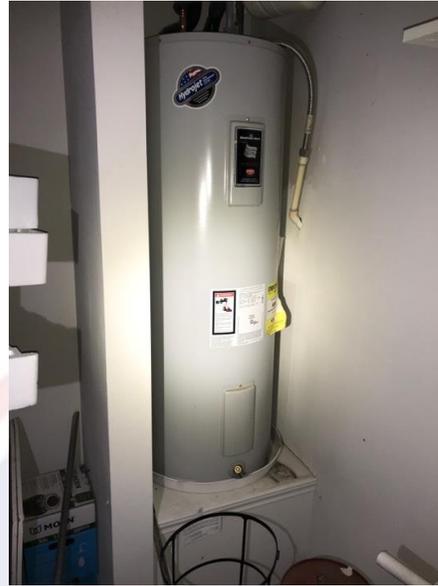
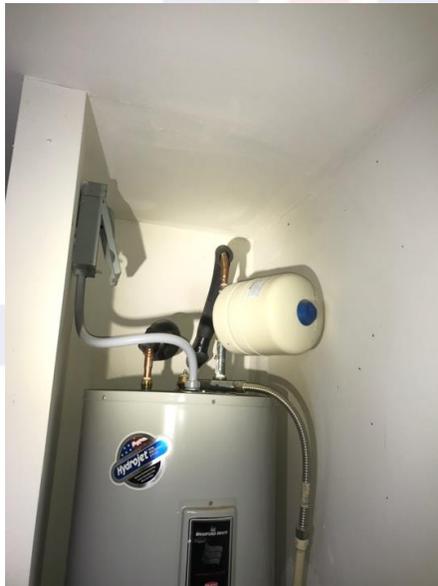
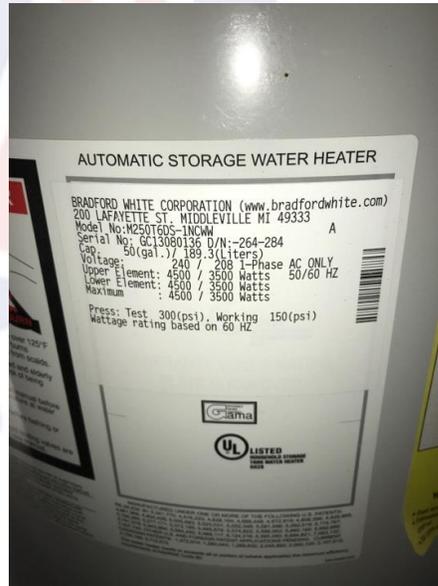
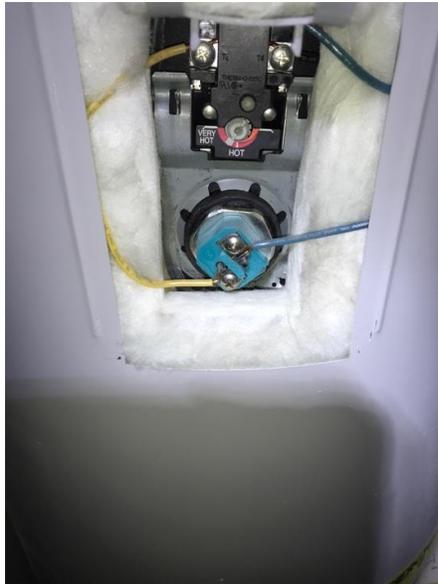
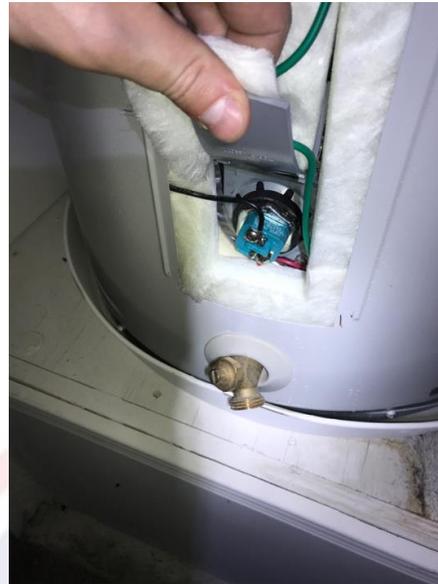
Photographs of the water heater(s):

An active leak was observed on the expansion tank or near the expansion tank of one or more water heaters. Inspector recommends correction by licensed plumber.

Inspector observed the water supply piping connecting to or from the water heater to be made of dissimilar metals (such as copper and iron/steel) that are in contact with each other without a dielectric union or fitting. This condition allows for the possibility of "Galvanic Corrosion", and TREC Standards of Practice require we report this condition as deficient.

Rust, corrosion, mineral residue or deterioration of the water supply piping/connectors was observed at some of the water supply piping or water connectors for one or more water heaters. Inspector interprets these observations as indicators of prior leakage. Inspector recommends further evaluation and replacement of rusted or corroded piping, connectors or valves by licensed plumber.

Inspector recommends the client have the water heater(s) further evaluated and corrected as necessary by a qualified licensed plumber prior to the expiration of any time limitations such as option periods. The observations made to support the rendering of this opinion include but are not limited to the following comments:

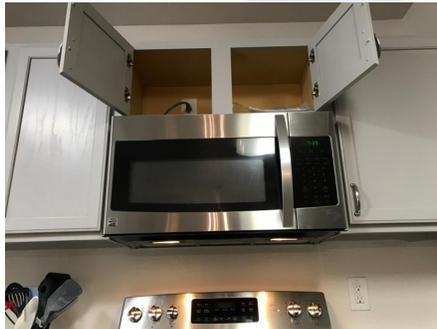
Photographs of the range hood exhaust system:

The range hood exhaust system in place is ductless and does not terminate to the exterior of the building. Instead, it recirculates the air in its vicinity and is dependent on a filter system installed to help remove oils from the air. Inspector recommends regularly cleaning your filter system and replacing the filters as necessary to prevent damage to the exhaust system.

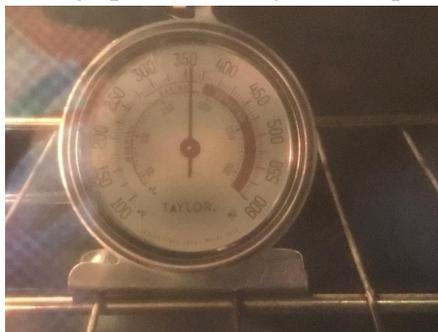
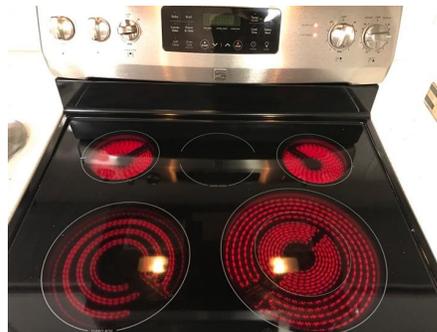
Photographs of the range, cooktop, and/or oven:

Inspector observed the absence of an anti-tip device installed on the oven, a manufacturer's requirement and building-code violation we are required to report as deficient.

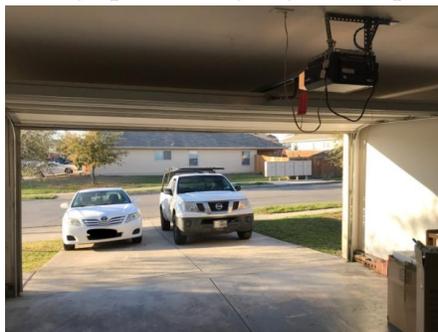
Photographs of the garage door opener:

Inspector observed that there is no auto-reverse mechanism on the garage door opener or the auto-reverse mechanism is not operational. The auto-reverse mechanism stops the garage door and reverses it when the door meets resistance (such as from a person). Correction may be as simple as adjusting the sensitivity control on the opener.

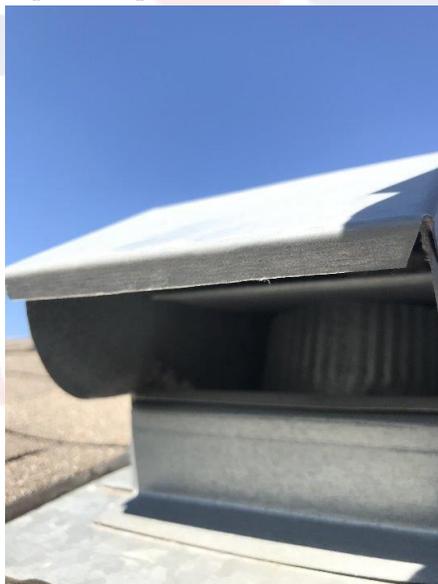
The rigid pipe dryer vent appeared to have been inserted too far into the dryer vent on the roof surface. This vent may not be venting adequately. What appeared to be darker-colored dust was observed around the dryer vent in attic; this may be lint that is not discharging correctly from the dryer vent. Inspector recommends further evaluation and having the vent cleaned by a qualified professional, such as an HVAC professional.
